REPORT OF TEST

EN91-0089.1
8/8/91

SUBJECT: Full Scale Room Burn Test of Reflective Insulation.

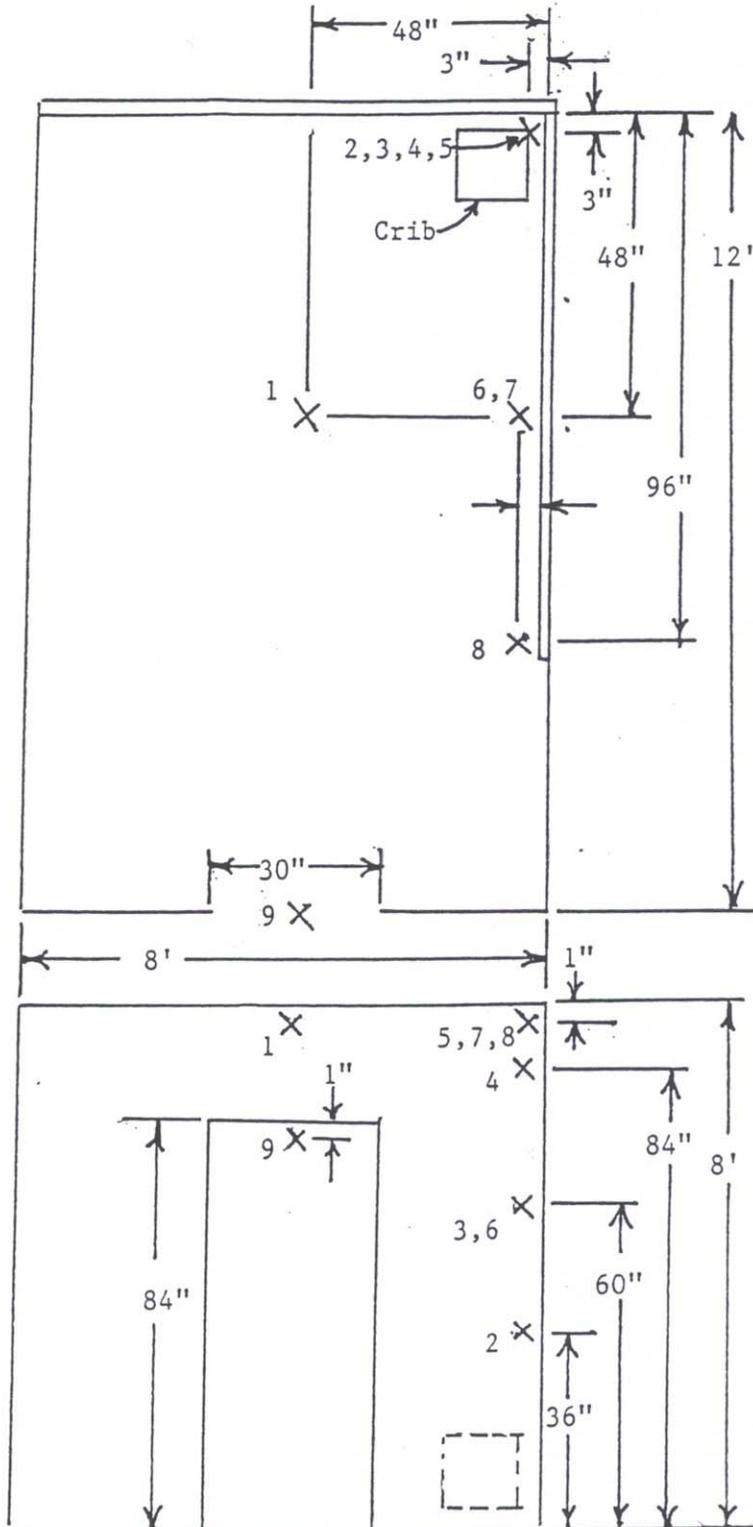
Figure 1. Burn Room Facility.

The test facility is a masonry block room 8 feet by 12 feet by 8 feet high with a doorway 30 inches wide by 84 inches high in the front end wall. The test room is lined with 5/8-inch Type X gypsum board. The ignition source is placed in the right hand, rear corner of the room.

Temperatures were measured using chromel-alumel thermocouples at 9 locations as shown in Figure 1 and Table 1. Temperatures were recorded every 15 seconds.

Table 1. Thermocouple Locations.

Thermocouple	Location
1	48 in. from either test wall, 1 inch below the ceiling.
2	Above crib, 3 in. from either wall, 1 in down from ceiling.
3	Above crib, 3 in. from either wall, 36 in. above floor.
4	Above crib, 3 in. from either wall, 60 in. above floor.
5	Above crib, 3 in. from either wall, 12 in. down from ceiling.
6	48 in. along side wall from back, 36 in. down from ceiling, 3 in. from wall.
7	48 in. along side wall from back, 1 in. down from ceiling, 3 in. from wall.
8	96 in. along side wall from back, 1 in. down from ceiling, 3 in. from wall.
9	1 in. down from the center of the doorway at the inside plane.
